## **TRANSPORTATION RESOURCES**

The road infrastructure of Shelburne and Buckland is comprised of two state highways and a network of roads serving the village center and outlying rural areas. Due to the rural nature of Buckland and Shelburne, cars and trucks are the primary modes of transportation for people and goods. According to the 1990 Census, 95% of Buckland households and 90% of Shelburne households own at least one vehicle. In addition, 66% of Buckland's and 81% of Shelburne's working population are employed outside of the town they live in. This places great importance on the road networks of both towns for commuting, particularly since neither community is well served by public transportation.

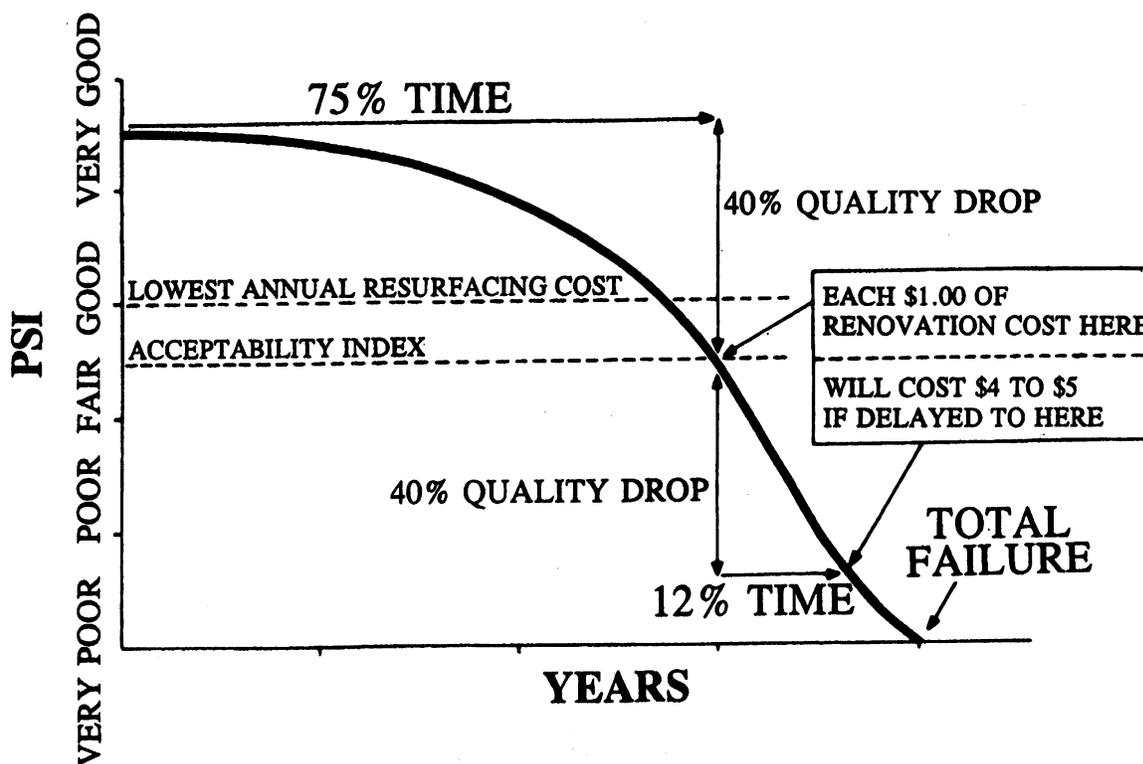
**Figure 3-1: Life Cycle of Asphalt Pavement**

**ROADWAY DETERIORATION vs TIME**

Source: 1996 Pavement Management Program Technical Report, Mass Highway Department

Figure 3-1 gives a graphical depiction of the general life cycle of an asphalt pavement. Under normal conditions of consistent weather and traffic patterns, a pavement will deteriorate by 40 percent in the first 75 percent of its life. During the next 12 percent of its life, the pavement will deteriorate by a further 40 percent. With proper timing of preventative maintenance measures during the first 75 percent of a pavement’s life, many years can be added to the functionality of the road at a lower overall cost.

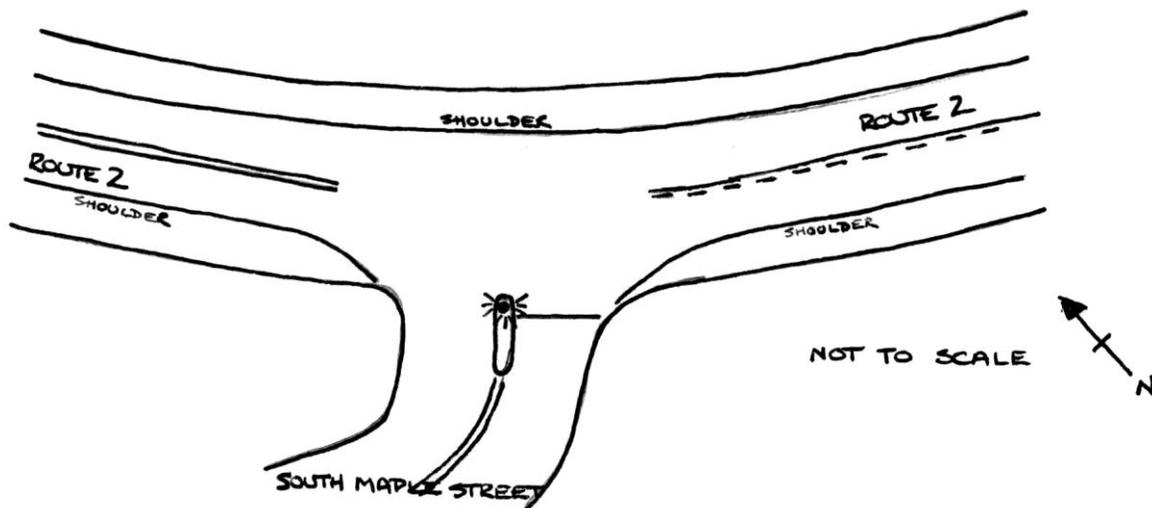
### Intersection of Route 2 (Mohawk Trail)/ Route 2A (South Maple Street), Shelburne

A site visit was made to this intersection during the evening traffic peak under clear and sunny weather conditions. This intersection is a "T" intersection with stop control on the minor street (South Maple Street) and provides the main access for westbound traffic to the village of Shelburne Falls. Route 2 at this point is wide with a 12 foot travel lane and approximately 12 foot paved shoulder in the westbound direction and a 12 foot travel lane and approximate 18 foot shoulder in the eastbound direction. The alignment is slightly curved with an uphill grade in the westbound

direction. This section of Route 2 has a posted speed limit of 50 mph and carries approximately 8,000 vehicles per day. South Maple Street approaches Route 2 at approximately a 90 degree angle, with a curve about 100 feet back from the intersection. South Maple Street has a slight downhill grade at the stop line for traffic entering Route 2. South Maple Street flares as it approaches Route 2 allowing ample room for simultaneous left and right turning vehicles at the stop line. A raised island is located between the two lanes of South Maple Street and flashing beacons and directional signs are located here also. Yellow beacons flash to warn drivers on Route 2 of the intersection at which they should proceed with caution and stay alert. The red beacon flashes in the South Maple Street direction to inform drivers that they must stop before entering the major roadway. This section of South Maple Street carries approximately 4,000 vehicles per day.

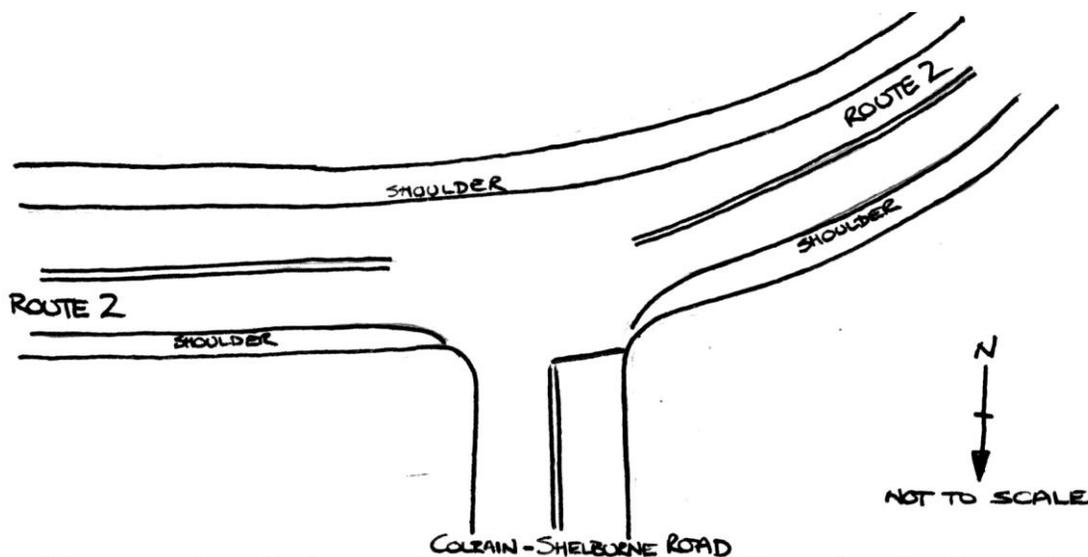
### Intersection of Route 2 (Mohawk Trail)/Colrain-Shelburne Road

A site visit was made to this intersection during the evening traffic peak under clear and sunny weather conditions. This intersection is a "T" intersection with stop control on the minor street (Colrain – Shelburne Road) and provides access to residences and farms in Shelburne and Colrain. It is also reported to be heavily used by recreational traffic accessing the mountains and ski areas in southern Vermont, especially on Friday and Sunday evenings. Route 2 at this point is wide with a 12 foot travel lane and approximately a 10 foot paved shoulder in the eastbound direction and a 12 foot travel lane and approximately a 7 foot shoulder in the westbound direction. Colrain-Shelburne Road intersects Route 2 where it curves with an uphill grade in the westbound direction. The crest of the hill on Route 2 is a few hundred feet to the west of the intersection with the road curving further with a slight downhill grade. This section of Route 2 has a posted speed limit of 50 mph and carries approximately 10,000 vehicles per day. Colrain-Shelburne Road approaches Route 2 at approximately a 90 degree angle. Traffic follows a steep downhill grade and comes to the stop line on a slight uphill grade. Due to the raised elevation of the intersection, a guardrail has been placed next to the pavement edge. The pavement flares slightly at the stop line allowing both right and left

turning vehicles to be there simultaneously. If the queue of traffic is three or more cars or one truck then access to the stop line is cut off. This section of Colrain–Shelburne Road carries approximately 2,000 vehicles per day.

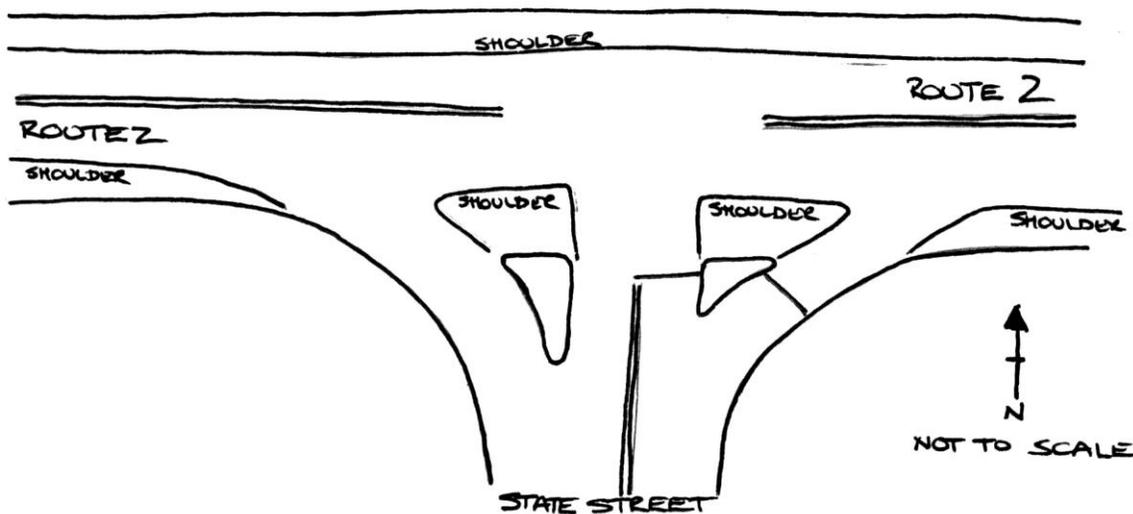
### Intersection of Route 2 (Mohawk Trail)/ Route 2A (State Street), Buckland

A site visit was made to this intersection during the evening traffic peak under clear and sunny weather conditions. This intersection is a “T” intersection with stop control on the minor street (State Street) and provides the first access for eastbound traffic to the village of Shelburne Falls. Route 2 at this point is wide with travel and paved shoulders in both directions. The alignment is relatively straight with an uphill grade in the westbound direction. This portion of Route 2 has a posted speed limit of 50 mph and carries approximately 4,000 to 5,000 vehicles per day. State Street approaches Route 2 at a 90 degree angle and has a slight uphill grade to the intersection. Two islands separate the turning movement lanes from and into State Street. The right turn lane exiting State Street is at approximately a 45 degree angle to Route 2. The right turn lane is

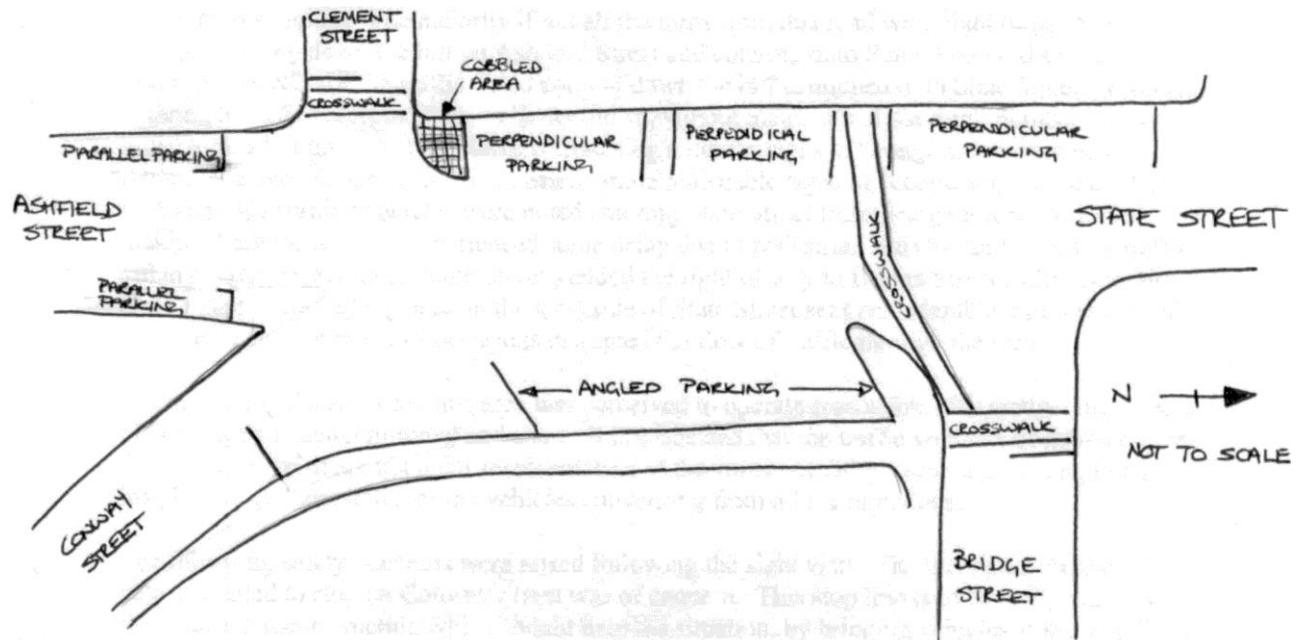
**The area on the Buckland side of Shelburne Falls where Conway Street, Ashfield Street, Clement Street, Bridge Street (the Iron Bridge) and State Street converge**

A site visit was made to this intersection during the afternoon peak, under clear and sunny conditions. This area sees the convergence of five different roads in the space of approximately 200 to 300 feet. State Street runs south from Route 2 and ends where Conway Street, Ashfield Street and Clement Street converge. Using a clock face to describe direction with north and State Street being 12 o'clock, Conway Street intersects at approximately 5 o'clock, Ashfield Street at 6 o'clock and Clement Street at 9 o'clock. Conway and Clement Streets operate under stop control with no control on Ashfield Street. Bridge Street intersects at 3 o'clock about 200 feet north of Ashfield Street. The section of State Street between Bridge and Ashfield Street is wide, but with perpendicular parking on the west side and angled parking on the east side the travel lanes are narrowed to no more than 12 feet each. Conway Street is relatively narrow with the retaining wall of Ashfield Street on its west side and a sidewalk and the Deerfield River on its east side. There is a slight uphill grade to the stop. The recent completion of the sidewalk reconstruction moved the stop line closer to State Street and angled it better for visibility of oncoming traffic. Ashfield Street approaches the area on a steep downhill grade and has parallel parking on both sides. Clement Street approaches the intersection on a downhill grade and has a pedestrian crossing marked in front of the stop line. Bridge Street approaches the area on the level. Both travel lanes are narrow (9 feet each), constricted by the bridge width. The stop line is set back from the intersection to accommodate a crosswalk.

Conway and Ashfield Street carry approximately 2000 vehicles a day each, Clement Street carries approximately 500 vehicles a day and Bridge Street carries approximately 5000 vehicles a day. Based on these traffic volumes, State Street in this area probably carries approximately 5000 vehicles per day.
